METALS HANDBOOK

VOL. 9
FRACTOGRAPHY AND ATLAS OF FRACTOGRAPHY

8th EDITION

Fractography and Atlas of Fractographs

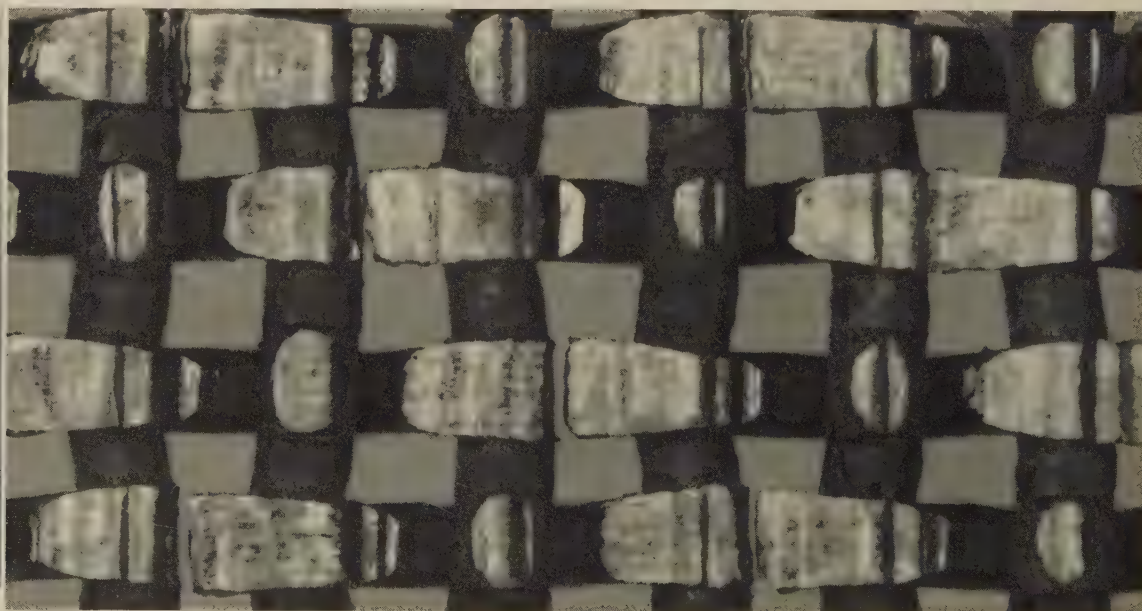
Photograph About 50×
5190 View of bottom of a Fourdrinier wire cloth used in papermaking. Material is phosphor bronze C. The warp wires, which are horizontal in this view, show very heavy wear where they cross the shuttle (or weft) wires. The wire cloth is a continuous belt that operates under high tension and severe reverse bending, which explains the fatigue fractures visible in at least eight locations where the warp wires have been thinned by wear. See 5191 to 5194 (facing page) for other fractures in Fourdrinier wire.

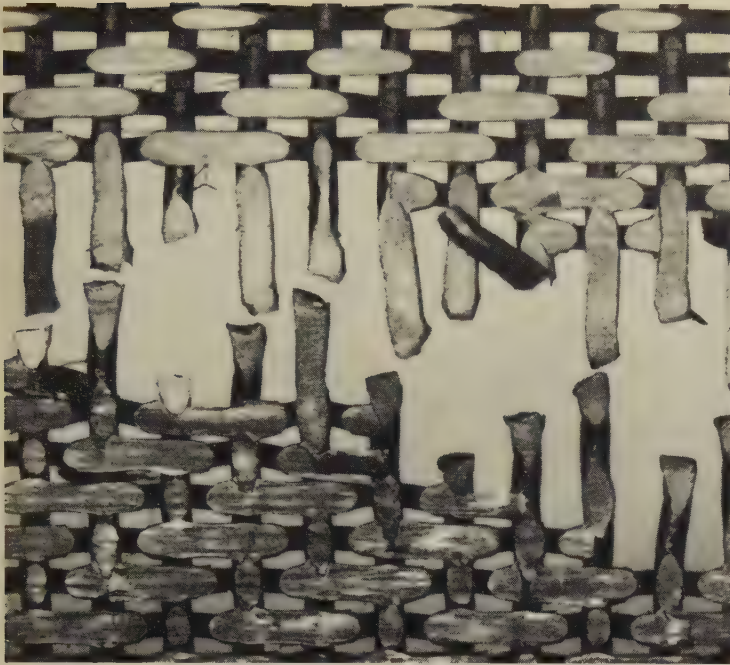
5191 View of bottom of a Fourdrinier wire cloth of phosphor bronze C that was removed from service after 14 days of operation. Heavy wear had occurred on both warp and shute (weft) wires. The fractures in the wires apparently occurred when the wires had worn almost completely through. The warp wires are shown horizontal in this view.

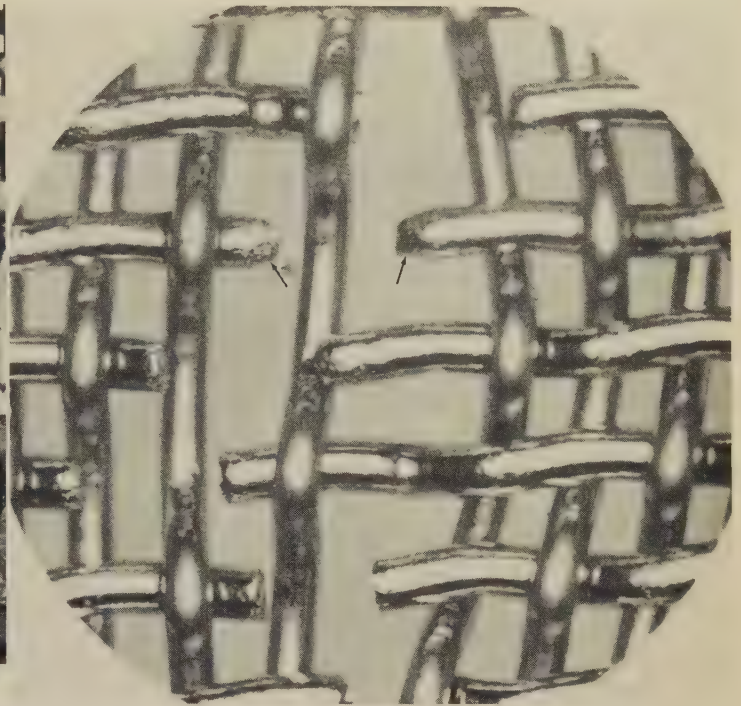
5192 Top view of a break in a Fourdrinier wire cloth of phosphor bronze C, showing fractures in shute (weft) wires. All but one of the fractures occurred by fatigue; the exception (at arrows) shows the necked-down profile of a tension fracture.

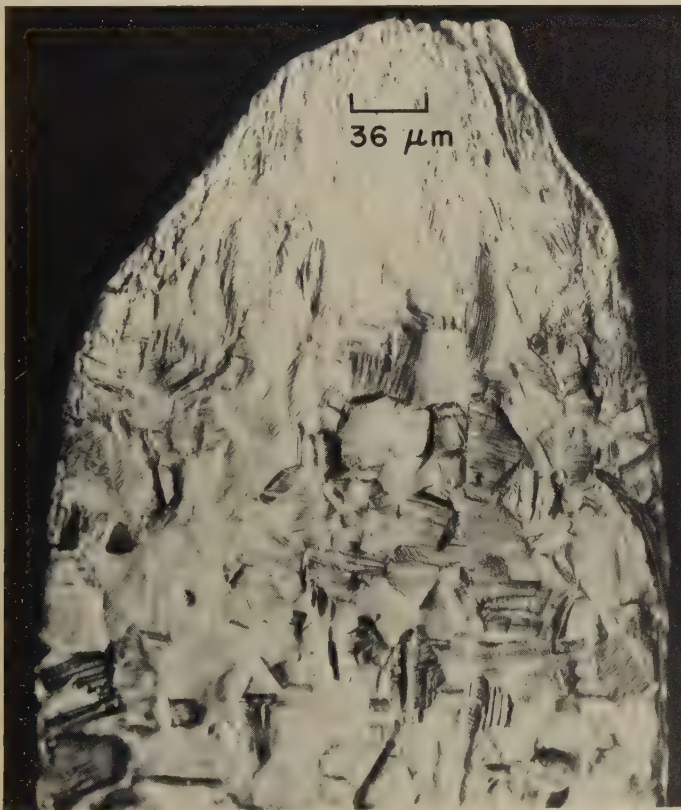
5193 Longitudinal section through a tension fracture in a warp wire of a Fourdrinier wire cloth of phosphor bronze C. Slip lines are visible throughout the microstructure. The plastic flow and the reduction in area at the fracture (top) were attributed to excessive warp tension.

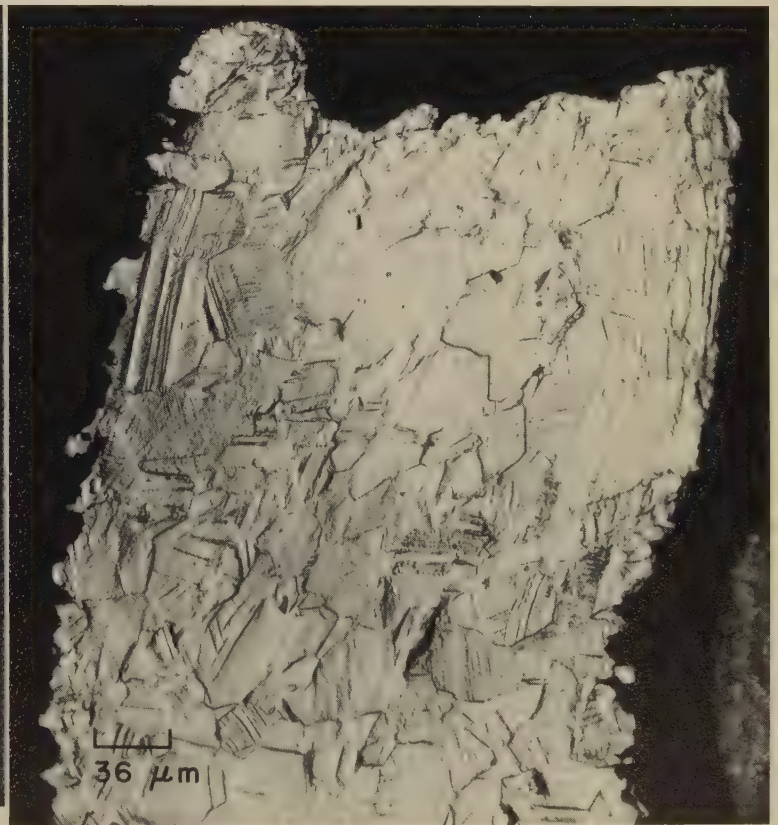
5194 Longitudinal section through a fatigue fracture in a shute (weft) wire of a Fourdrinier wire cloth of 80Cu-20Zn brass with 0.5% Sn added. The profile of the fracture is shown at top. Note corrosion pitting visible on the wire surface at left and at right.

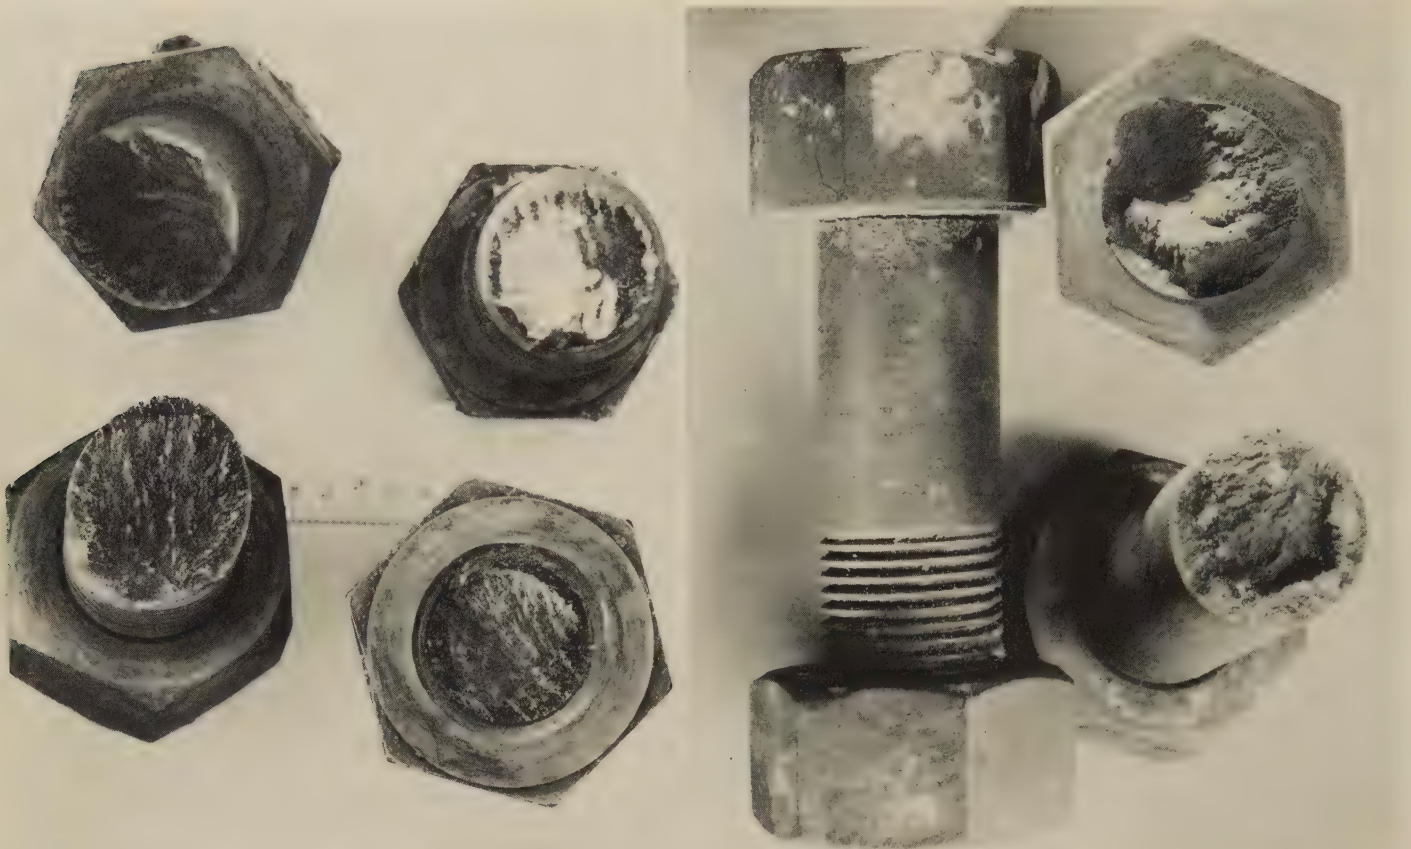
5195, 5196 Fractures resulting from stress-corrosion cracking in 91Cu-7Al-2Si aluminum-silicon bronze bolts from the cover of a de-aeration pump that had been subjected to a marine atmosphere. At left (5195) are the surfaces of fractures in four fitted bolts. At right (5196) are the mating fracture surfaces of a broken standard bolt, and a standard bolt (with nut) that contains a stress-corrosion crack in the fillet beneath the bolt head. Although the aluminum contents of the fitted and standard bolts were low (7.5% and 6.5% respectively), the silicon contents were high (2.0% and 3.0% respectively), which resulted in a two-phase (alpha-plus-beta) microstructure. A single-phase alloy might have been more resistant to corrosion.

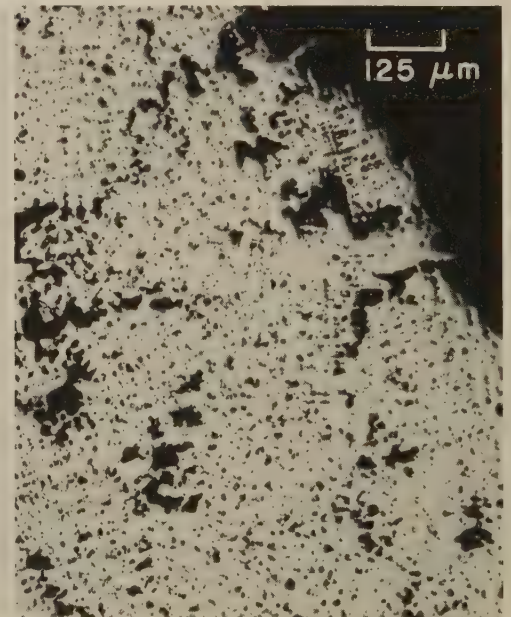
5197, 5198 At left (5197) is a view of a fractured cock valve that parted in the threads. The valve had been cast of 85Cu-5Zn-5Sn-5Pb lead red brass, which normally provides a very sound structure. At right (5198) is a section through the valve in 5197, adjacent to the fracture, showing an excessive amount of shrinkage porosity scattered throughout the structure. Fracture was attributed to stress concentrations that were generated by the shrinkage pores.

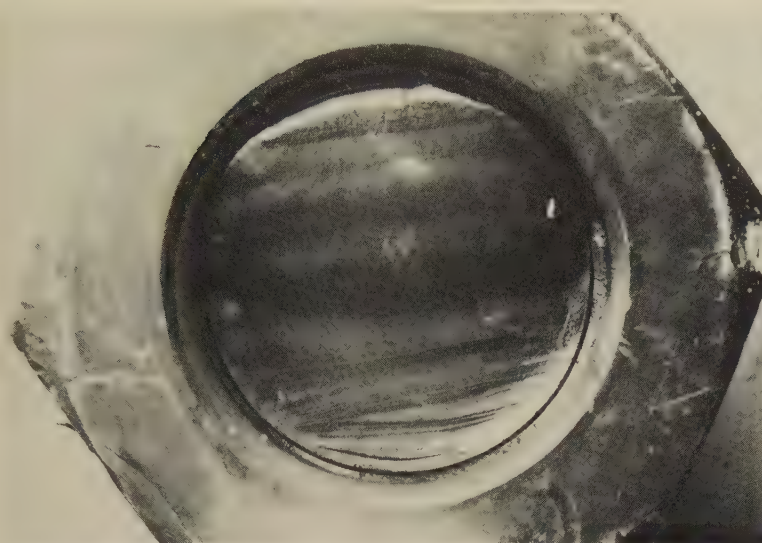
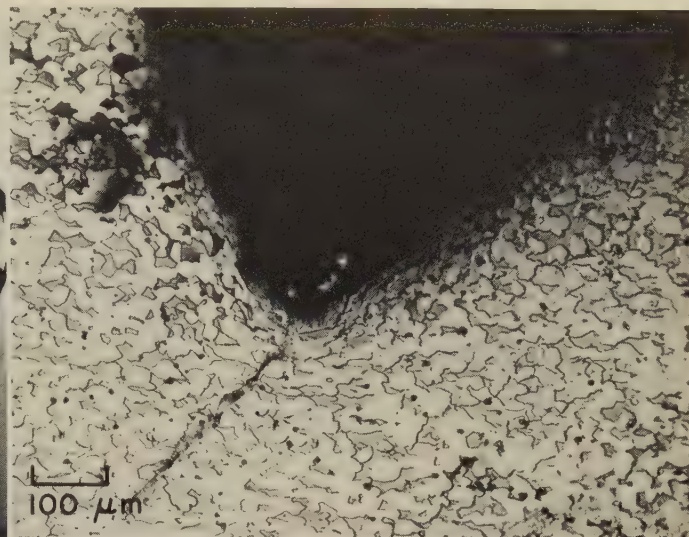
5199, 5200

At left (5199) is the surface of a fatigue fracture in an air-pump rod that broke in service. The material is 60Cu-37.8Zn-0.7Mn-1.5Fe manganese bronze. The fatigue crack originated in the root of a sharp V thread and penetrated nearly the entire bolt (shown inside its nut) before final, fast fracture occurred. At right (5200) is a longitudinal section through the broken pump rod in 5199, showing the beginning of a second fatigue crack in the thread root next to that in which the fracture occurred.

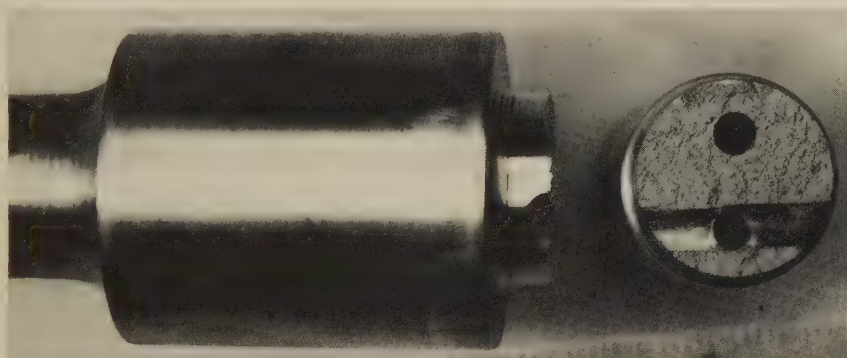
Cleavage fracture in a cast 48Cu-35Ni-11Sn-6Pb alloy valve spindle from a pump. The apparent cause of fracture was internal porosity combined with the presence of three drilled holes, which weakened the section and provided stress raisers. See also micrograph 5202 (right).

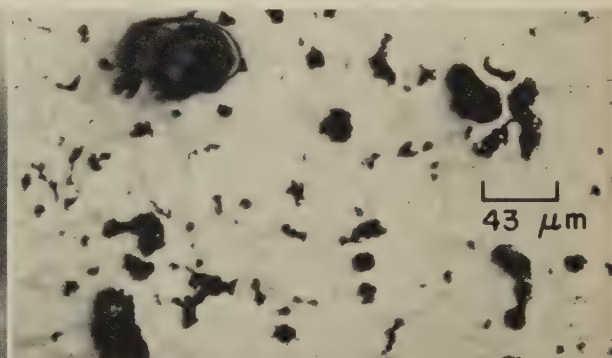
5202 A section through the fractured cast valve spindle shown in photograph 5201 (left), taken at a region adjacent to the fracture. Scattered porosity is plainly evident.

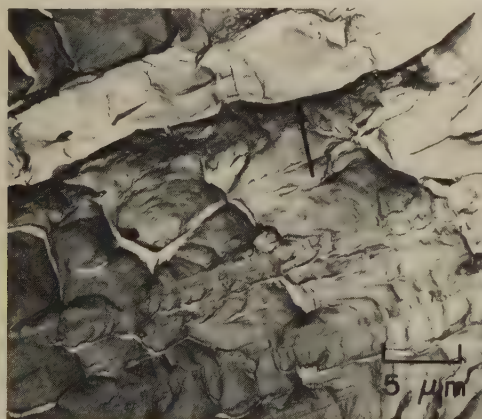
Surface of a fracture produced at room temperature, in a drop-weight tear test, in a specimen of titanium alloy Ti-2Al-2Zr-2V-1Mo, showing a long stringer (arrow) that was broken apart and stretched.

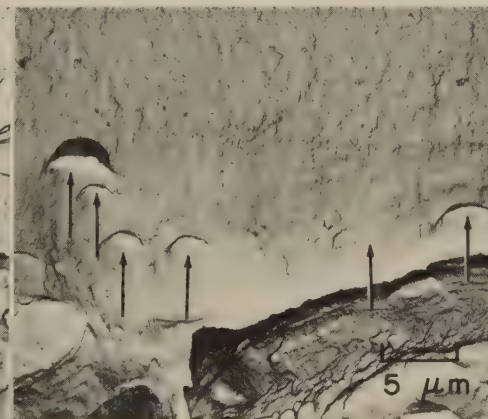
Direct carbon replica (Pd-shadowed) of the surface at the root of an intentionally formed fatigue crack in a titanium alloy Ti-2.5Al-16V specimen, showing tear dimples (at arrows) that formed during the early stages of crack growth.

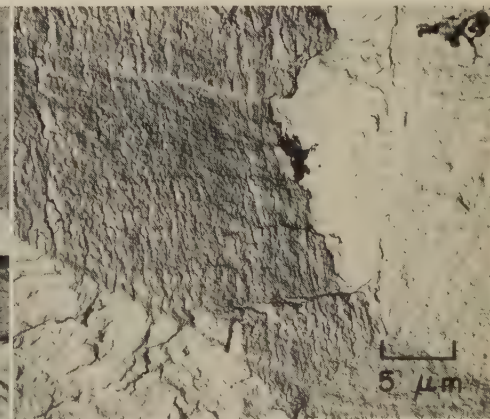
Replication of the surface of a fatigue fracture in a specimen of titanium alloy Ti-2.5Al-16V, showing fatigue striations. The striations exhibit noticeable changes in orientation where they intersect grain boundaries.

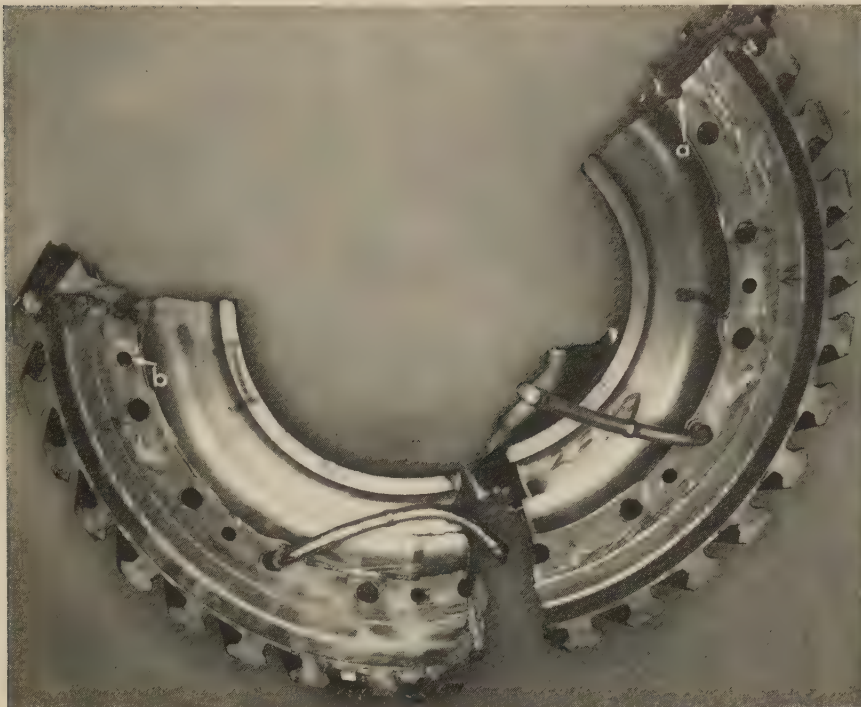
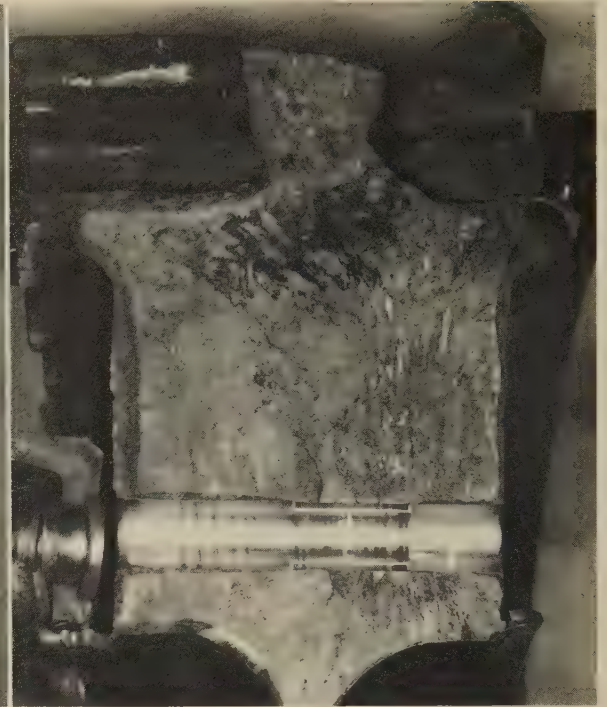
5206, 5207

At left (5206) are two portions of a fractured titanium alloy Ti-6Al-4V second-stage compressor disk from a jet engine. Of the three radial fractures, the one at upper right, which passes through the bolthole marked "a", was found to be the primary fracture, exhibiting several fatigue-crack origins adjacent to the hole. The two other fractures showed no sign of fatigue. At right (5207) is a surface of the fracture through the bolthole at arrow "a" in 5206. Several fatigue cracks originated at locations within brackets "c" and "d". Deep tool marks in the bore of the hole are visible between arrows "e" and "f"; a section through the hole marked "b" in 5206 showed no such deep tool marks. Average tensile properties of two specimens cut from the disk were 1007 MPa (146 ksi) tensile strength, 17.5% elongation and 39% reduction of area. See also 5208 and 5209 (below), and 5210 to 5213 (facing page).

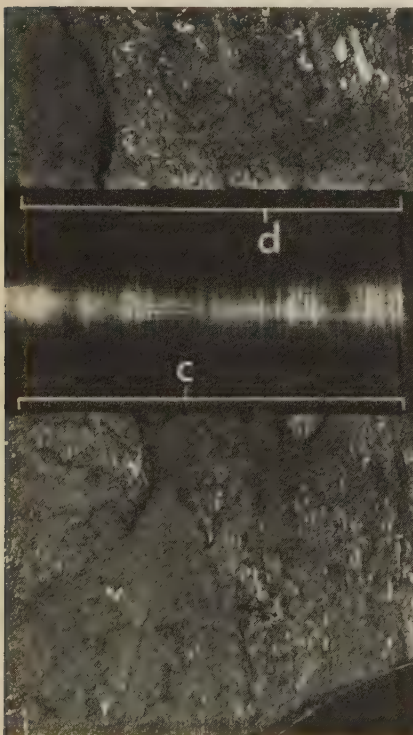
5208

Enlarged view of the fatigue-crack regions (marked by brackets) at the edges of the bolt-hole in 5207. The cracks grew in both directions from the hole.

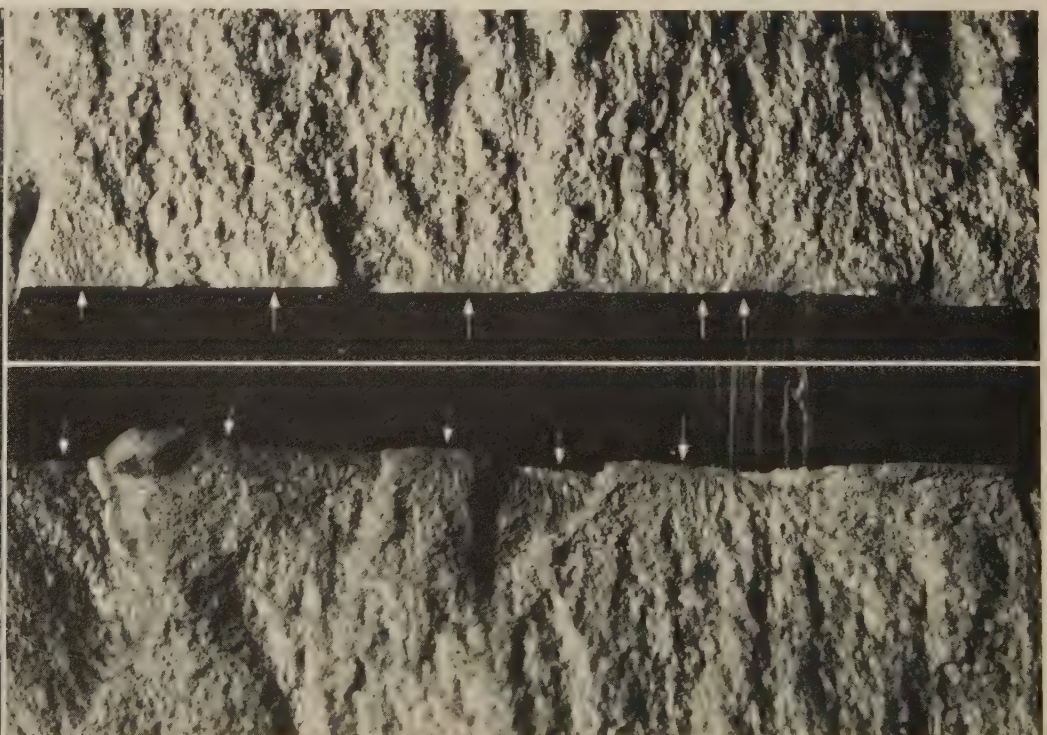
Separate, higher-magnification views of the bracketed regions of the edges of the compressor-disk bolthole in 5207 and 5208, shown correctly aligned opposite each other. Visible are beach marks in several fatigue-crack zones (at arrows). These separate cracks penetrated only a short distance before joining to form common fronts, which then advanced toward both the rim and the bore of the disk.

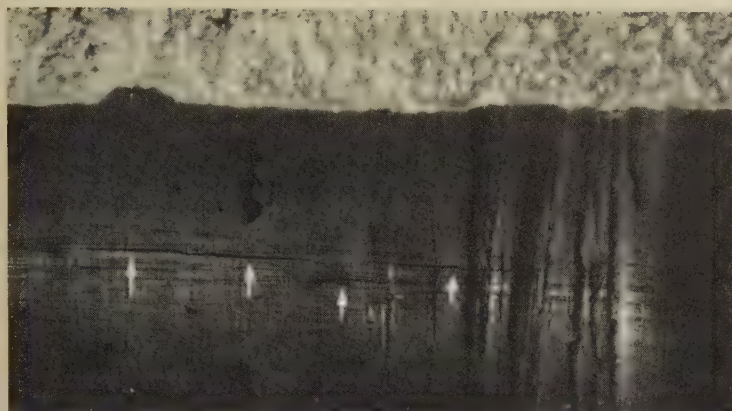
5210 A view of the bore of the bolthole at arrow "a" in the fractured titanium alloy Ti-6Al-4V compressor disk in 5206 (facing page), showing more clearly the deep tool marks faintly visible in 5207 to 5209. The arrows mark locations of longitudinal secondary cracks in the bore of the hole.

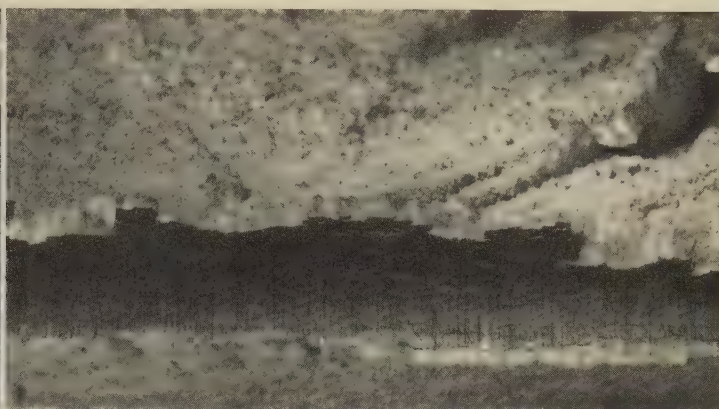
5211 A view of the edge of the bolthole through which passed one of the secondary radial fractures (at left or at bottom) in the compressor disk in 5206. Note the irregular shear-overload cracks at the edge of the hole, which show no characteristics of fatigue, and the irregular secondary cracks in the bore.

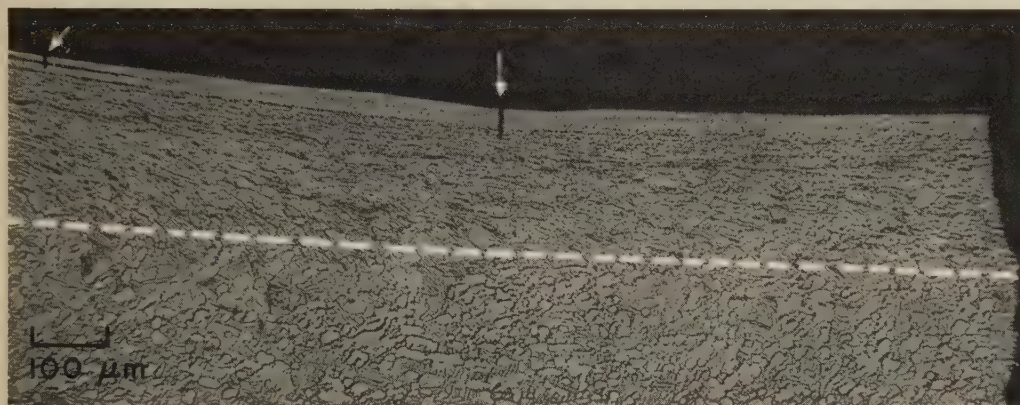
5212, 5213 At left (5212) is a section through one of the fatigue-crack zones at one of the bolthole edges in 5209, taken transversely to the hole. The fracture surface is shown in profile at right, and the bore of the hole is shown in profile at top. Note the layer of cold worked metal above the dashed line. At right (5213) is a section through the same general area as that in 5212, but taken longitudinally to the hole. Here, as in 5212, a cold worked layer can be seen (at top); severe surface flow in the bore of the hole is visible also. This damaged condition of the bore surface, and the deep tool marks shown in 5210, probably caused the fatigue fracture.

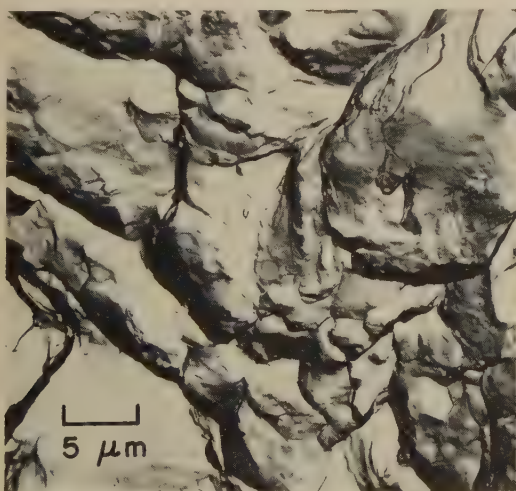
5214 Surface of a tension-overload fracture in a specimen of titanium alloy Ti-6Al-4V. Both large and small dimples are present. The large dimples exhibit surface ripples that formed during flow.

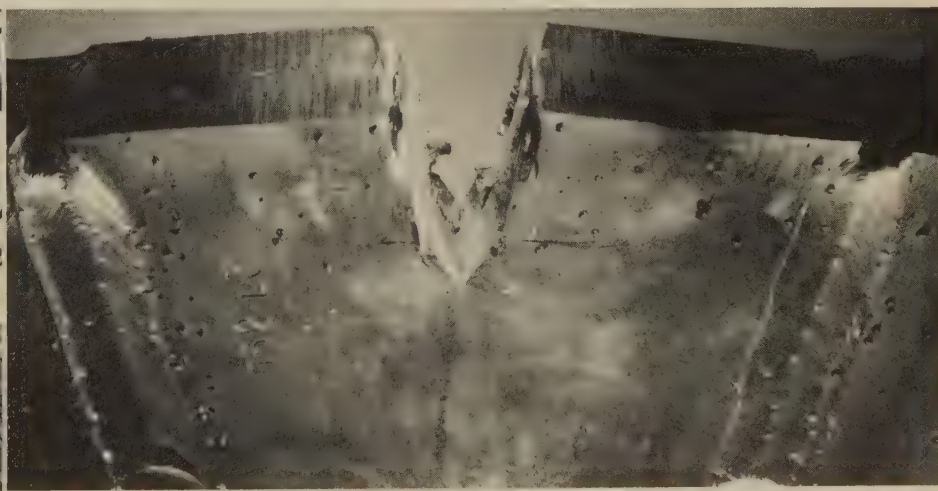
5215 A drop-weight tear-test specimen of titanium alloy Ti-3Al that absorbed the energy of a 10,000-ft-lb blow by bending with little propagation of the fatigue crack previously prepared at the notch root. The crack merely widened as the metal at the root of the crack flowed plastically as in a simple tension test. Electron fractography disclosed that stretching was the predominant feature in the surface of the crack.

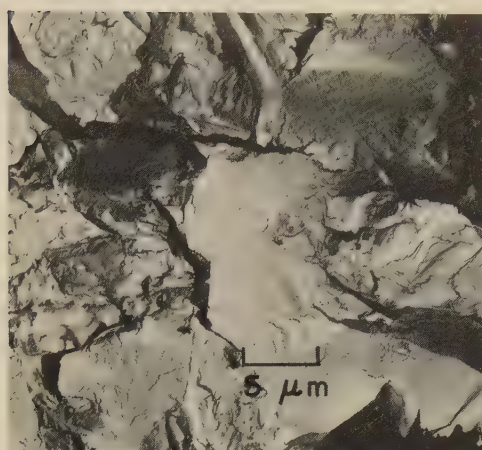
5216 Fracture resulting from stress-corrosion cracking in a specimen of titanium alloy Ti-6Al-4V that was stressed in methanol. The crack path is transgranular (by cleavage). See also 5217 (right).

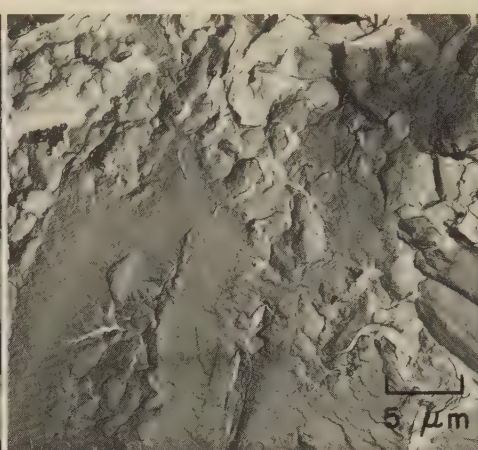
5217 A companion fractograph to that in 5216, from the same specimen of titanium alloy Ti-6Al-4V, but showing an area farther from the fracture origin. Visible are what appear to be a few small dimples.

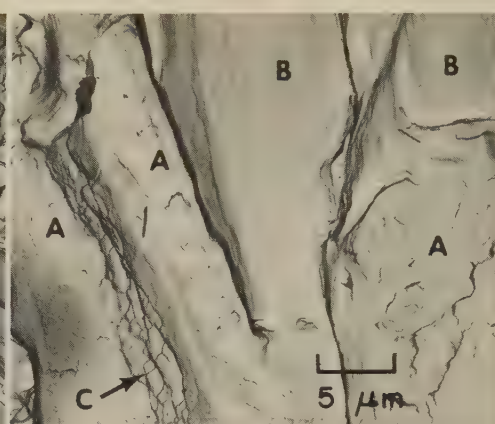
5218 Bending fracture in a specimen of titanium alloy Ti-6Al-4V that broke by stress-corrosion cracking in 3½% NaCl (areas A) but that also exhibits regions of stretching (areas B) and a step containing what appear to be dimples (arrow at C).

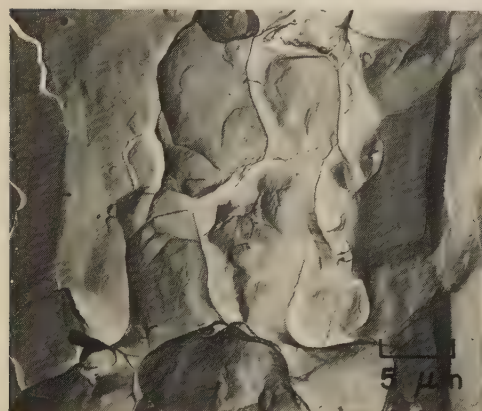
5219 Surface of a fracture in a specimen of titanium alloy Ti-7Al-1Mo-1V that was broken in a drop-weight tear test, consisting mostly of dimples. A feature that apparently is a tear ridge (vertical) is visible at far right.

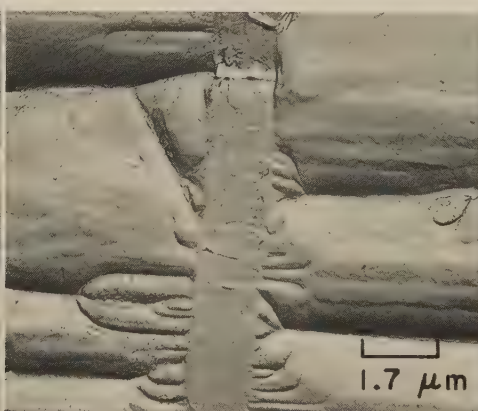
5220 Fracture produced by tension overload in a specimen of titanium alloy Ti-7Al-2Cb-1Ta, showing staining and very large dimples. Vertical band at center is where a crack initiated at a second-phase region and propagated to left and right.

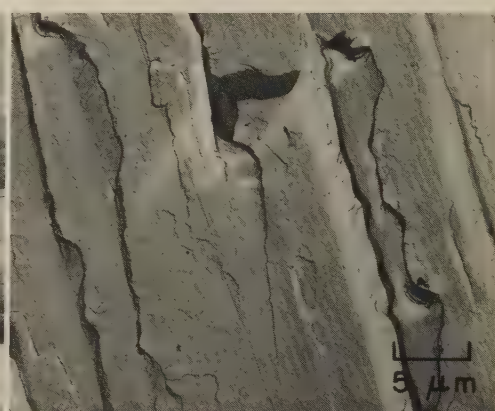
5221 Fracture resulting from stress-corrosion cracking in a chill cast specimen of titanium alloy Ti-7Al-2Cb-1Ta that was stressed in distilled water, exhibiting facets that were produced by essentially pure cleavage.

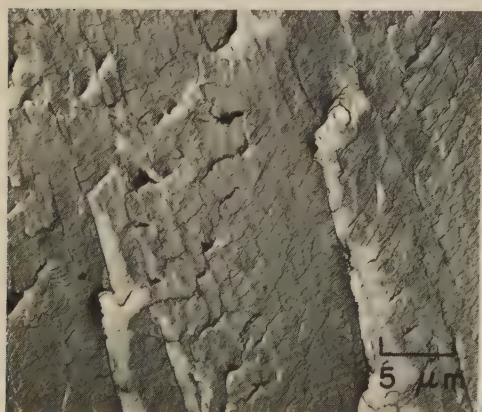
5222 Cleavage fracture in a specimen of titanium alloy Ti-7Al-2Cb-1Ta, produced by stress-corrosion cracking in methanol. Note the regular array of fissures, which are parallel to the crack front. See also fractograph 5223 (right).

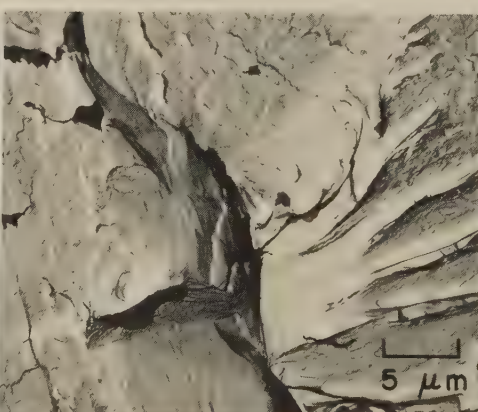
5223 Companion fractograph to that in 5222, from the same specimen, but taken at the stress-corrosion-crack front. In general, the facets here show features of cleavage; in contrast, the facets at top center show what apparently are ripples.

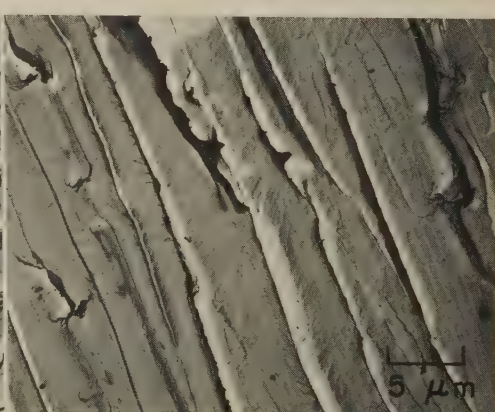
5224 Cleavage fracture in another specimen of titanium alloy Ti-7Al-2Cb-1Ta, also produced by stress-corrosion cracking in methanol. Note the similarity of the cleavage facets here to those in 5221, which were produced in distilled water.

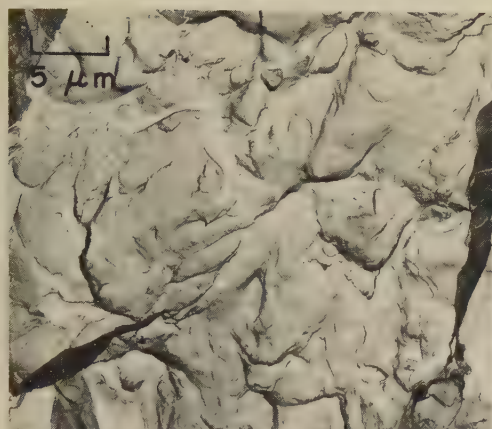
TEM fractograph (p-c replica) 2000×
5225 Surface of a tension-overload fracture in a specimen of titanium alloy Ti-7Al-3V, displaying assorted large to small dimples. Dark lines suggest deep fissures. The two black areas (at lower left and at right) are artifacts.

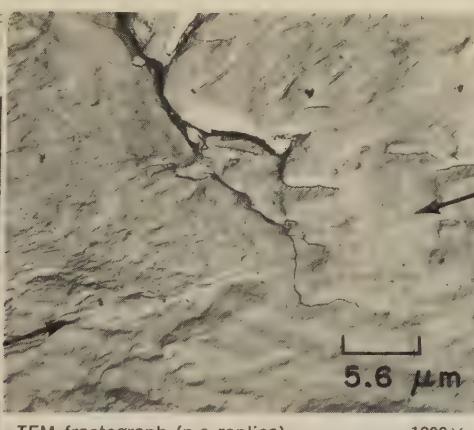
TEM fractograph (p-c replica) 1800×
5226 Fatigue fracture in a specimen of titanium alloy Ti-8Al-1Mo-1V tested in air, then in vacuum. Fine fatigue striations from testing in air are evident above the demarcation indicated by the arrows. Below this demarcation, crack growth occurred in vacuum and no striations were formed.

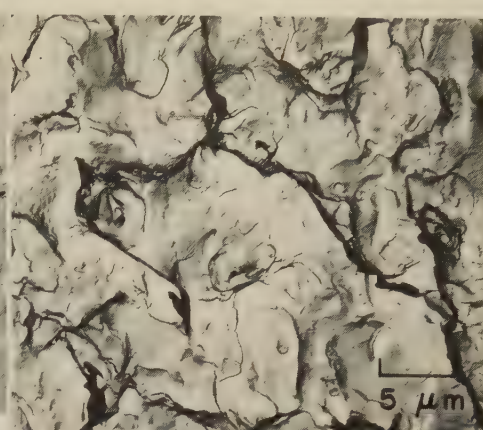
TEM fractograph (p-c replica) 2000×
5227 Fracture in a specimen of titanium alloy Ti-8Al-1Mo-1V broken by impact after stress-corrosion cracking. This area, which is from the fast-fracture region, shows dimples that were formed by microvoid coalescence.

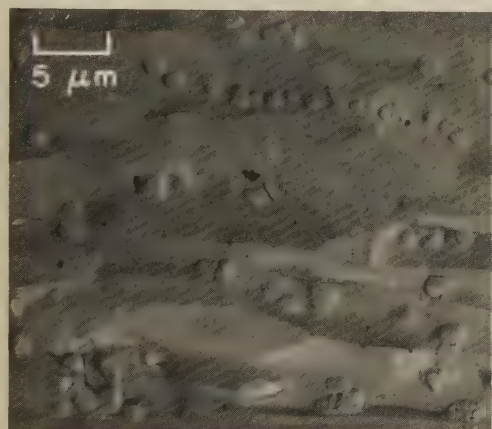
TEM fractograph (p-c replica) 2000×
5228 Surface of an impact fracture in a broken rod of sintered tungsten, showing that separation of the rod was intergranular. Evident are numerous sintering pores that resemble second-phase particles.

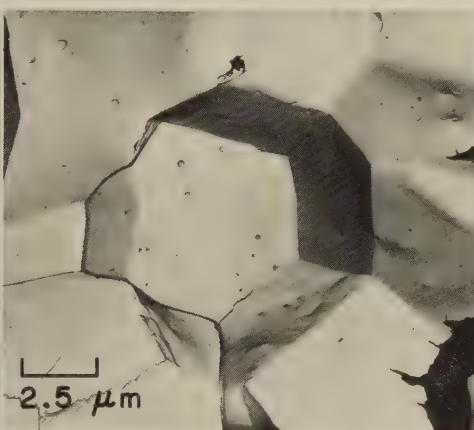
TEM fractograph (p-c replica) 4000×
5229 A very clean intergranular fracture in sintered tungsten that was broken by impact. Note the several very flat separated-grain facets; small sintering pores can be seen in several of the facets.

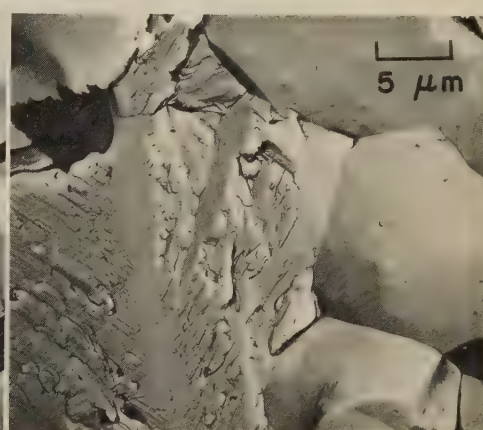
TEM fractograph (p-c replica) 2000×
5230 Impact fracture in sintered tungsten that had been recrystallized, showing separated-grain facets (at right) and cleavage facets (at left); the cleavage facets exhibit twins in the {112} plane.

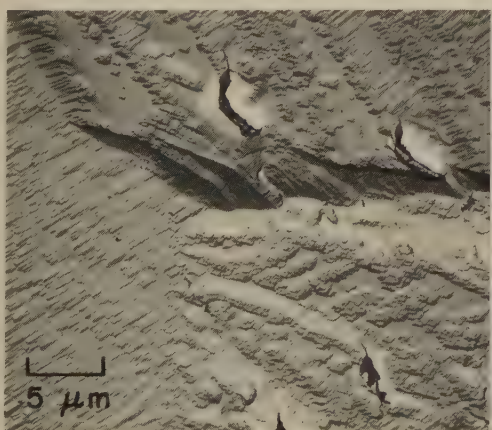
TEM fractograph (p-c replica) 2000×
5231 Surface of an impact fracture in a single crystal of tungsten that was etched with H₂O₂ after fracture. Cleavage along both the {100} and {113} planes is evident. See also fractographs 5232 and 5233.

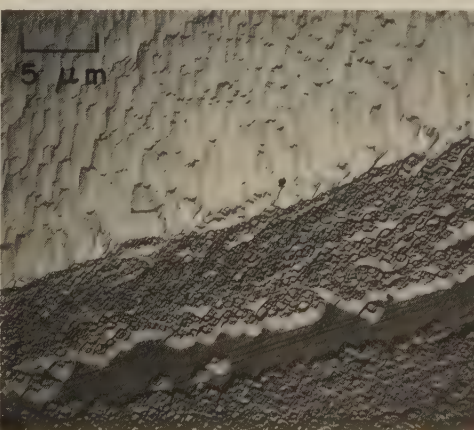
TEM fractograph (p-c replica) 2000×
5232 Impact fracture in a tungsten specimen etched with H₂O₂ after fracture. Cleavage facets are evident, showing pits with two distinctly different appearances due to different grain orientations.

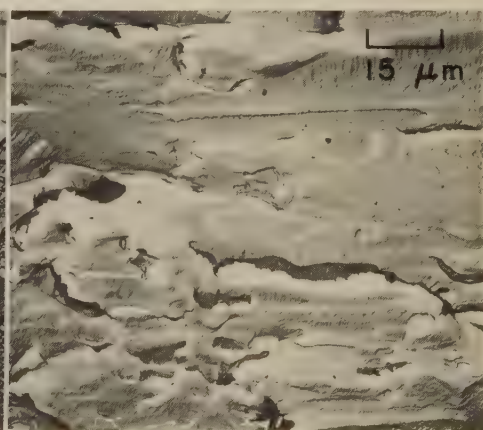
TEM fractograph (p-c replica) 650×
5233 Impact fracture in a specimen of tungsten, showing cleavage steps. The fracture surface has been only lightly etched with H₂O₂ and appears very different from those in 5231 and 5232 (at left).
